# Development and Application of BEOL Polymer Residue Removal Technology

## Abstract

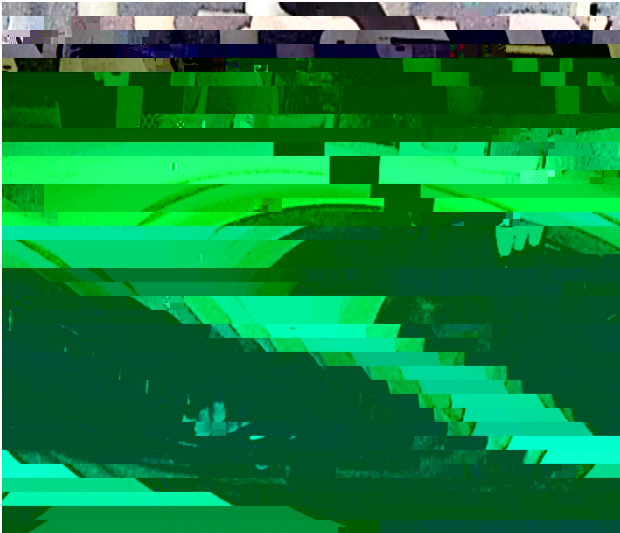
Fig. 6. (a) Captured image of ST250 layer thickness at a rotation rates of 400 rpm. (b) Water layer thickness profiles at the rotation rates of 200, 500 and 1400 rpm respectively [4].

Hitoshi et al. found that in single-wafer wet cleaner, the local thickness of water layer is related to various parameters, such as wafer rotation speed and radical distance from wafer center [4]. As shown in Fig. 6(b), at the rotation rates of 200, 500 and 1400 rpm, the water layer thickness does not present steady curves as the radical distance changes. At the radial distance from wafer center of around 10mm, both liquid layer thickness and the radical velocity are much smaller than other zones (radical velocity profile is not shown). We suspected that the combination of thinner liquid layer thickness and slower radical velocity will result in poor chemical wetting at this local area, which consequently results in ball-type defect deposition. This phenomenon is more pronounced to high-viscosity chemical, such as ST250. The captured image in Fig. 6(a) also confirms this prediction. As shown in Table 1, viscosity of ICS8000 is much lower than ST250’s, which is the reason why ICS8000 does not suffer the ball-type defects (Fig. 5).
